Insensitive Munitions Technology Transition Program Composite Case Captive Carry Qualification (C⁴Q) Final Report

by
Brandy Corley Flotten
Research and Engineering Sciences Department

JULY 2005

NAWCWD Technical Publication 8598

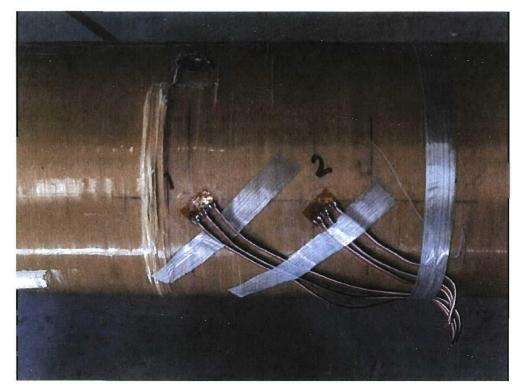
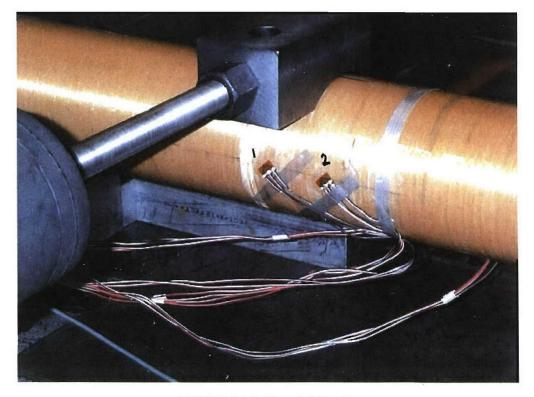
Figures B-9 and B-10 provide the ultimate load test displacements and selected strain data, respectively. Figures B-11 and B-12 show gage 2.

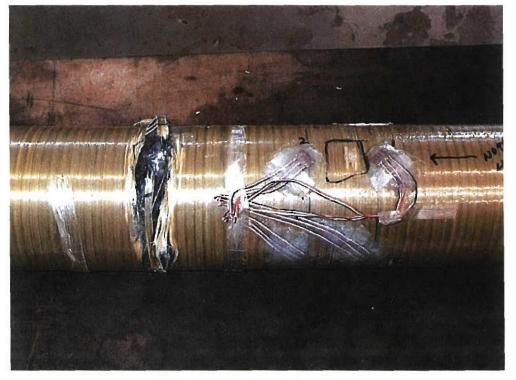
FIGURE D-15. Failure Photograph 2.

As the load was increased, there were no cracking or popping sounds until failure at the maximum load of 8109 pounds.

The compressive axial strain at the edge of the warhead section is presented in Figure D-12. Again, note the zero offset due to the elevated temperature. The thermocouple readings are shown in Figure D-13. They establish that thermal equilibrium was reached. Note that the control gage was on the surface of the composite tube away from the metal underlying structure of the warhead. As a control, this most closely represented the "applied external temperature" of the environment. The location of thermocouple (TC 6) is at the forward hanger at 9 o'clock (looking aft with hanger at 12 o'clock). The control thermocouple (TC 7) is near the aft impact point at 12 o'clock. Thermocouple (TC 8) is 20 inches aft of the forward hanger at 10 o'clock. Figures D-14 and D-15 are photographs of the failure.

The C⁴Q composite blue tube passed the ultimate bending test. The test was performed with hot/wet conditions and impact damage to the tube. Based on the required load of 7480 pounds and the failure of the tube at 8109 pounds, the ultimate M.S. for the damaged tube is as shown in Equation D-3.

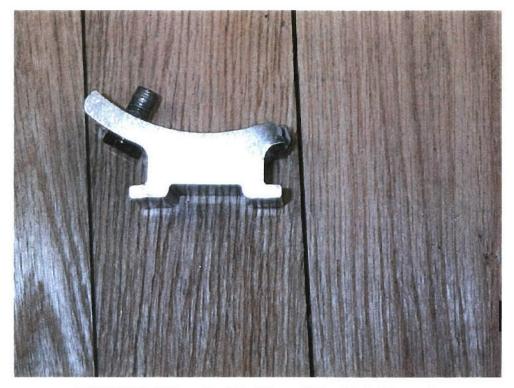
As the load was increased, there were no signs of progressive damage until the forward hanger failed at 19,005 pounds. The failure was a catastrophic net section tensile failure at the bolt holes. Figures F-6 and F-7 show the failure.

FIGURE F-7. Ultimate Load Test Hanger Failure Mode (Close-up).

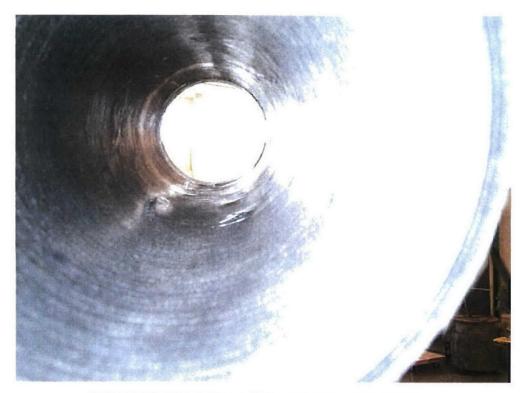
FIGURE J-9. Middle Hanger Failure (No Release), Inside View.

Both tubes failed in a similar manner. The failures were initiated inside the composite tube, along the edge of the wound in hanger pad, and then failed in the fasteners. Both failures were comfortably above the ultimate load. In addition, there was insignificant difference between the regularly manufactured article and the test article with a built-in disbond between the wound-in pad and the composite case. This confirms the mechanically locked-in design functions as expected, despite a bond failure. Figures J-9 through J-12 show the failures.

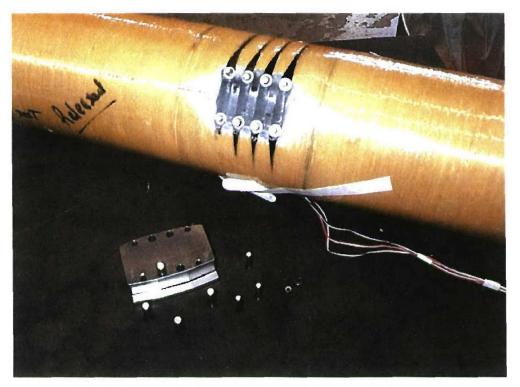
FIGURE J-12. Middle Hanger Failure (With Release), Outside View.

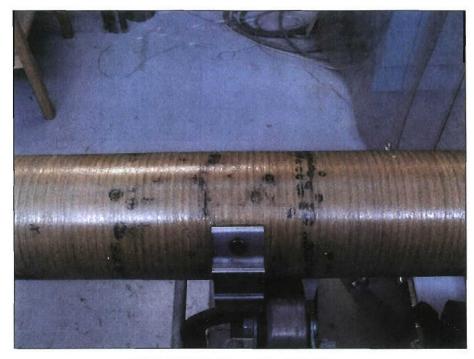
FIGURE R-10. Grease Pencil Markings.

The NDI results do not indicate significant internal damage. But, they do show areas that are probably vibration-induced internal damage. The vibration test article was subjected to a three-point bending test. This test is the same as specified in the C^4Q bending test report. That test is described in Appendix S. The results of that test were a positive margin of safety of +0.54 with a factor of safety of 1.5 and load increases to cover hot/wet and impact damage material knockdown factors.

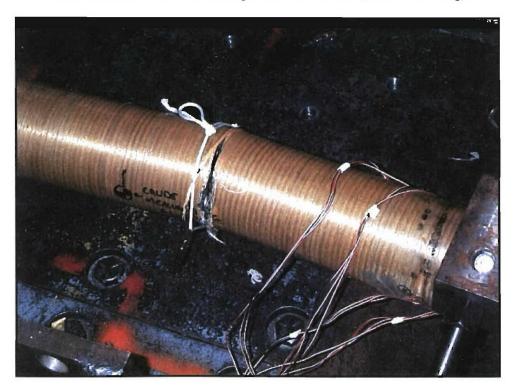
As the load was increased, there were no audible popping noises until catastrophic failure at 18,023 pounds. The strain gages for the rosettes at the forward hanger and the aft edge of the warhead (both on the compressive side of the tube) are presented in Figures S-7 and S-8. The data show nice linear behavior well past the 11,700-pound ultimate load. The strain gage in the area of all the NDI indications shows that damage is occurring after ultimate load that results in a strain redistribution and a softening of that area. This may help to explain why the location in the final failure is NOT in this area but a little farther aft on the tube. Figures S-9 and S-10 show the failed area on the tube.

FIGURE S-9. Ultimate Failure Location (View 1).

FIGURE S-10. Ultimate Failure Location (View 2).

The C^4Q composite blue tube passed the ultimate bending test after a full lifetime of vibration testing. The test was performed with the load increased to cover a factor of safety of 1.5 plus the additional material margins allowed for hot/wet and impact damage. Based on the increased required load of 11,700 pounds and the failure of the tube at 18,023 pounds, the margin for the post vibration test C^4Q hardware is shown in Equation S-5.

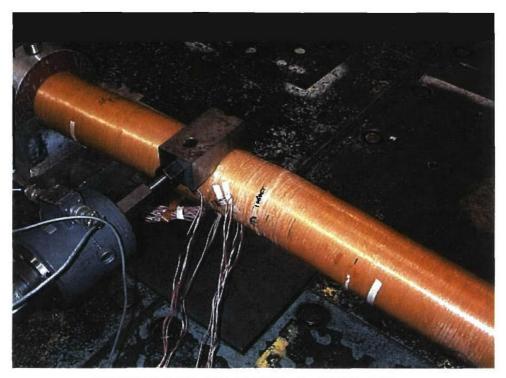
Blue tube Serial Number 008 was instrumented with four rosette strain gages and displacement potentiometer as specified in the drawing and as shown in Figure T-17. Figures T-18 and T-19 show the failed tube. The maximum measured load and displacement were 9920 pounds and 0.37 inch, respectively. The load history, load versus displacement, and load versus microstrain plots for this test are shown in Figures T-20 through T-25 for the yield load condition and in Figures T-26 through T-31 for the ultimate load condition.

FIGURE T-18. Blue Tube Serial Number 008 After Failure.

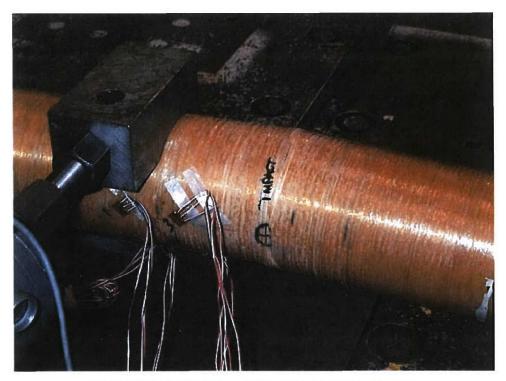
FIGURE T-19. Failed Area of Blue Tube Serial Number 008.

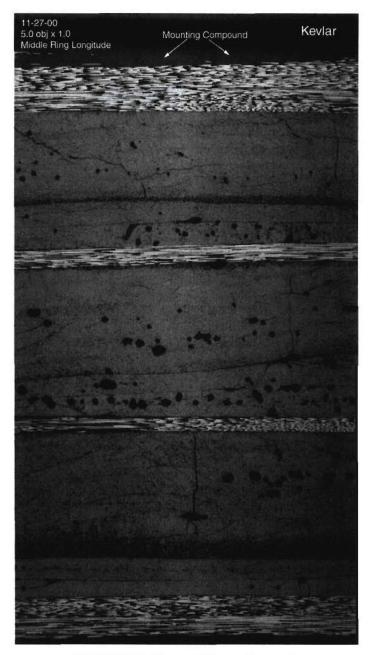
FIGURE U-4. Post-test Photo-micrograph.

Sections of the test specimens were mounted, polished, and photo-micrographed. The results indicated no apparent adverse effects or damage. Appendix U documents this effort.

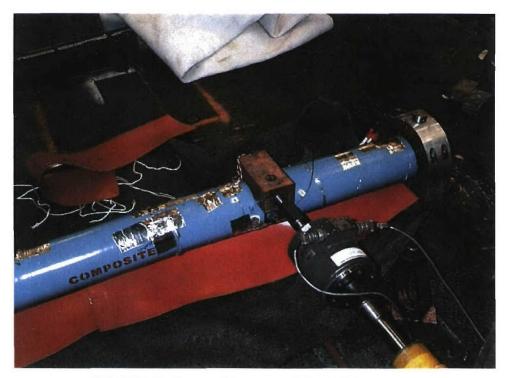
FIGURE X-3. Post-test Photograph of Test Article (View 1).

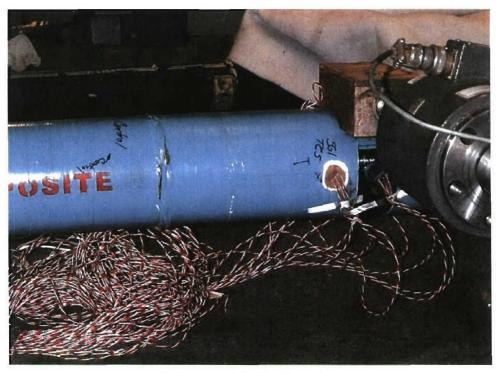
FIGURE X-5. Failure Location.
